**58<sup>th</sup> ECTC, Lake Buena Vista, May 27–30, 2008**

## **Drop Test Reliability of Lead-free Chip Scale Packages**

Andrew Farris, Jianbiao Pan, Ph.D., Albert Liddicoat, Ph.D.  
California Polytechnic State University at San Luis Obispo

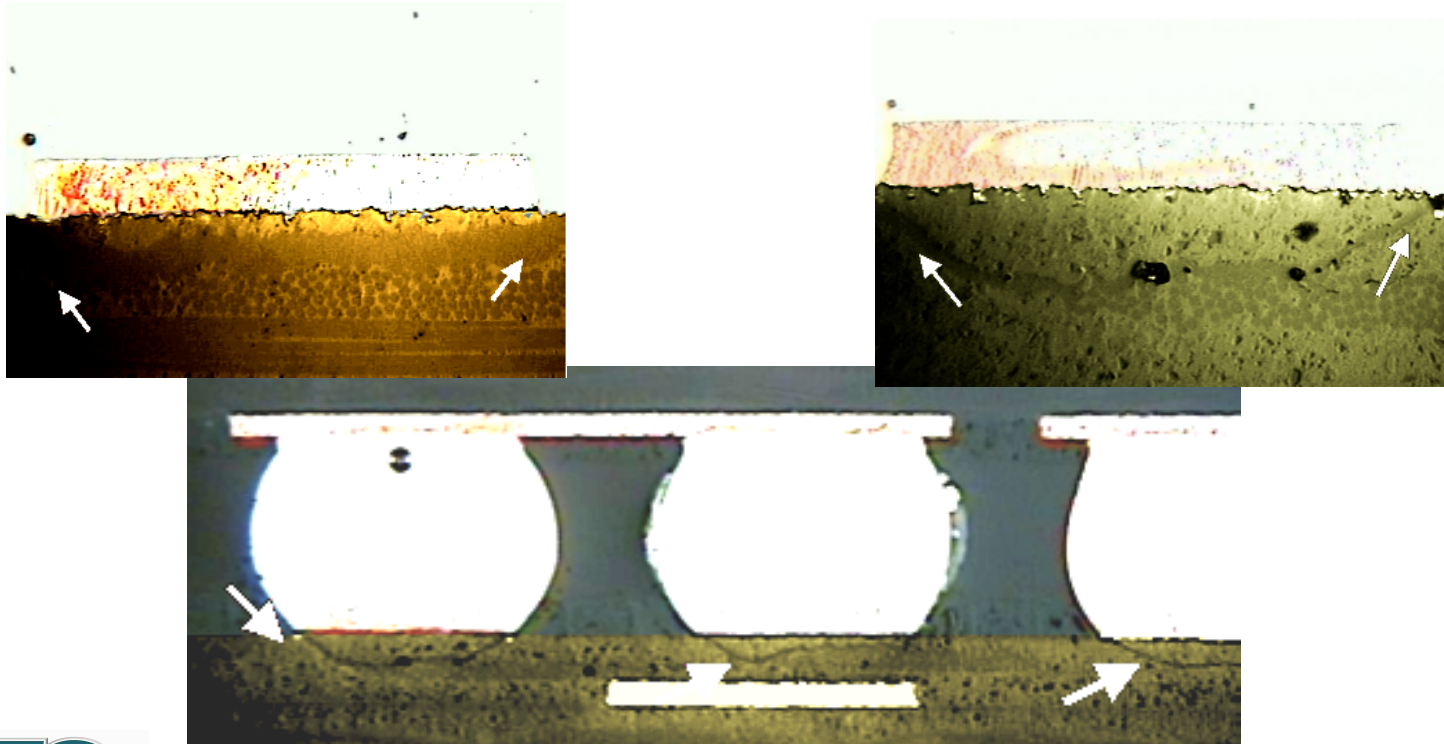
# Cracking Under Pads (Cratering)

Cracks develop underneath the copper pads, allowing the copper pad to lift away from the board

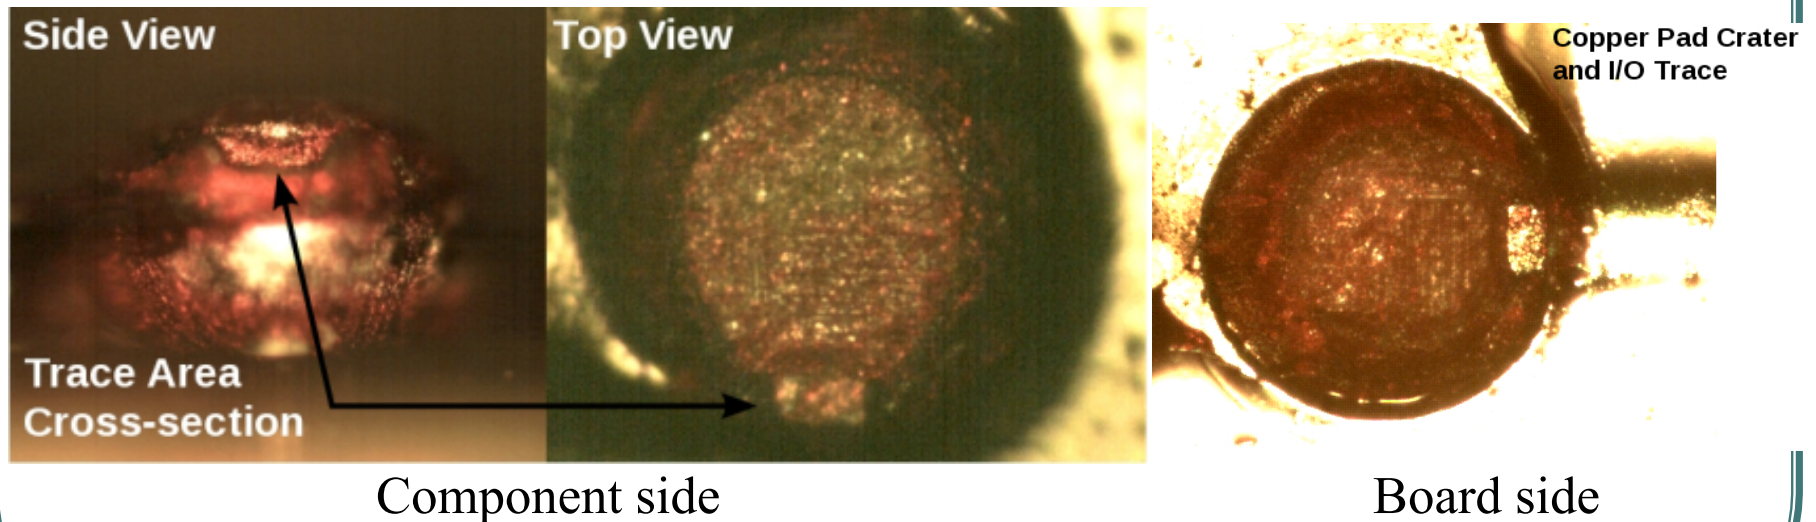
# I/O Trace Failure

- Input/Output (I/O) traces that connect to the daisy-chain 'resistor' were often broken
- Many components had this broken trace and no other identifiable failure

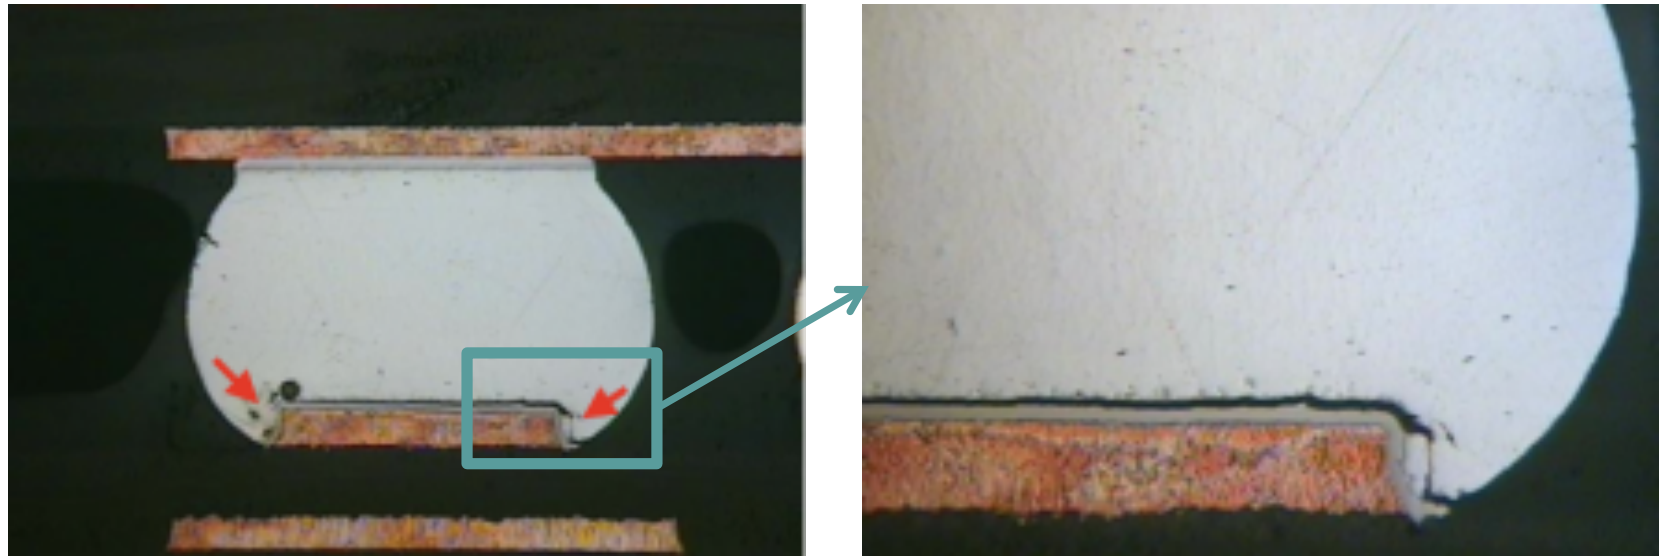
# Solder Fracture Failure

- Cross-sectioned solder joint is shown to be cracked near the board side copper pad

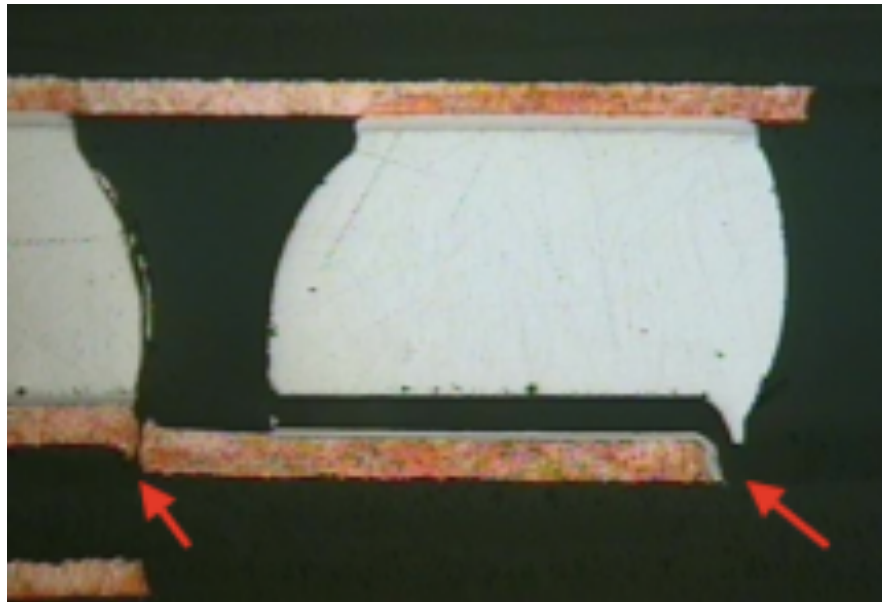
# Solder Fracture Failure

- Cross-sectioned solder joint is shown to be cracked near the board side copper pad
- Copper trace failure also shown (left side)

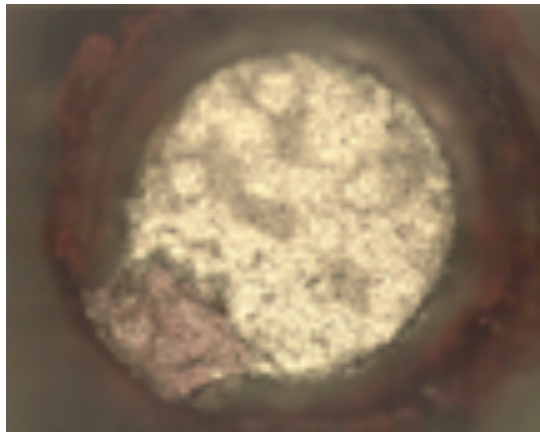
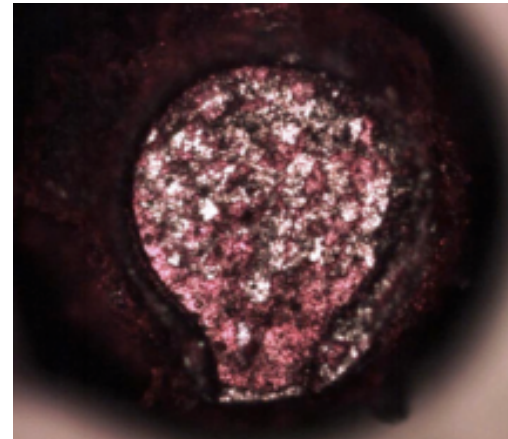
# Dye Stained Solder Fractures

- Dye stained solder fractures were found
  - Partial solder fracture (left) was not completely fractured before the component was removed
  - Complete solder fracture (right) was fully fractured before the component was removed

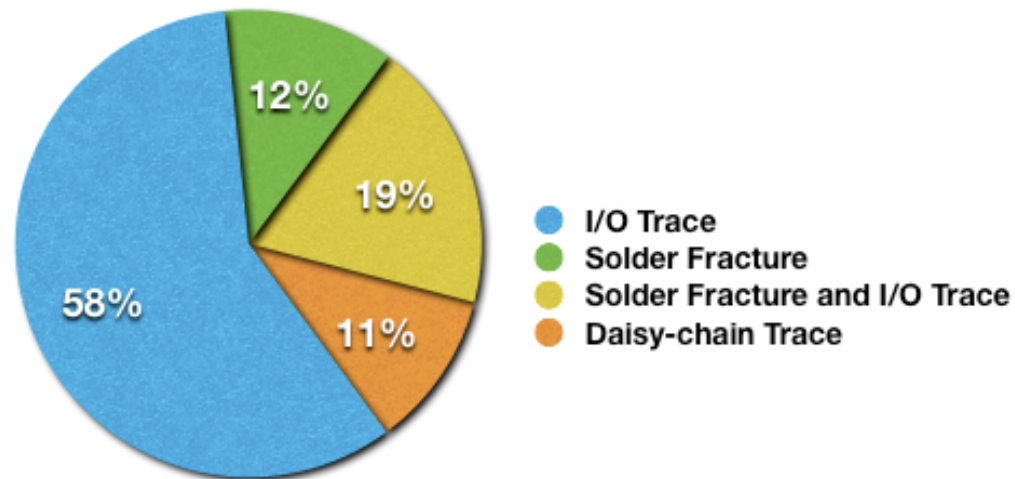
# Failure Mode Comparison

- I/O Trace and Daisy-chain Trace failures are both caused by pad cratering
- Pad cratering was present on 88% of electrically failed components, and is directly responsible for 69% of all electrical failures

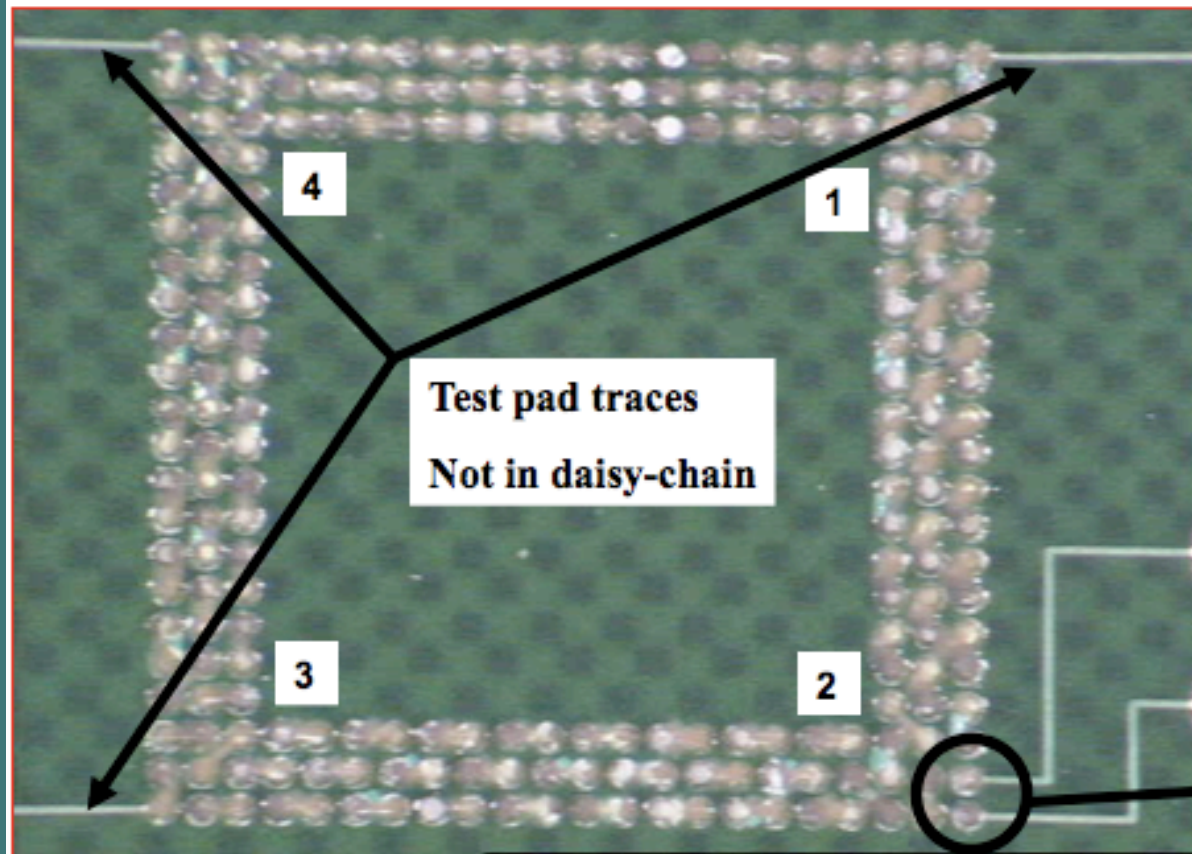
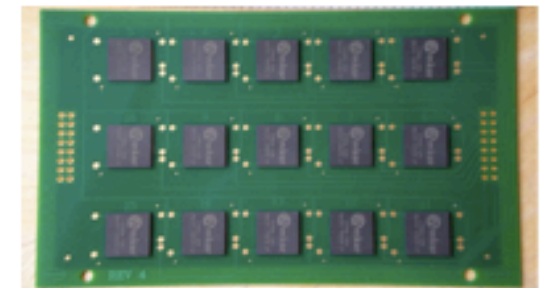
# I/O Trace Failure Location

Area where I/O failure occurs most often
