Failure Analysis Techniques

Pad Cratering and Electrical Failure

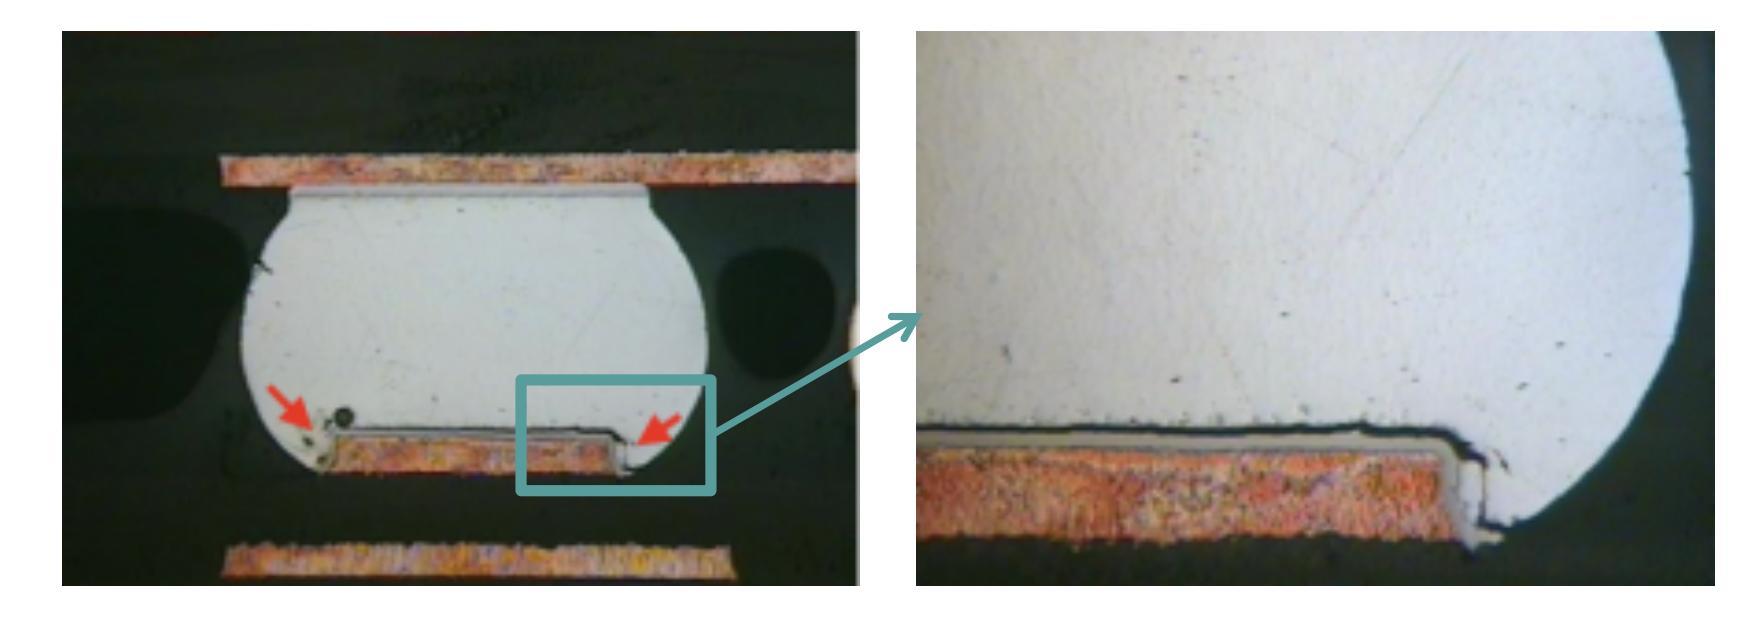
Solder Fracture Failure

Cross-sectioned solder joint is shown to be cracked near the board side copper pad

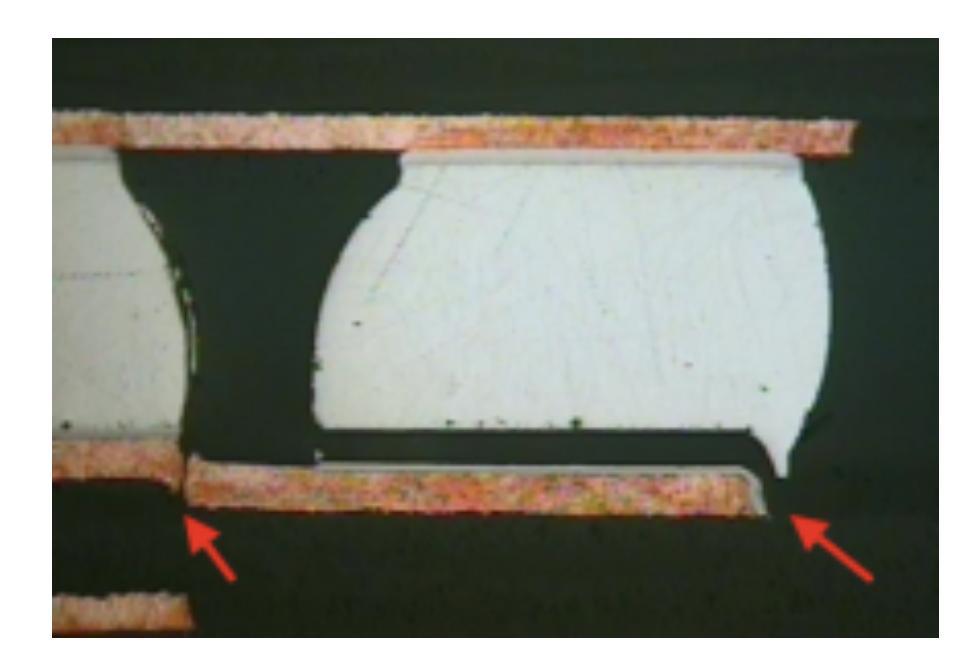
Solder Fracture Failure

- Cross-sectioned solder joint is shown to be cracked near the board side copper pad
- Copper trace failure also shown (left side)

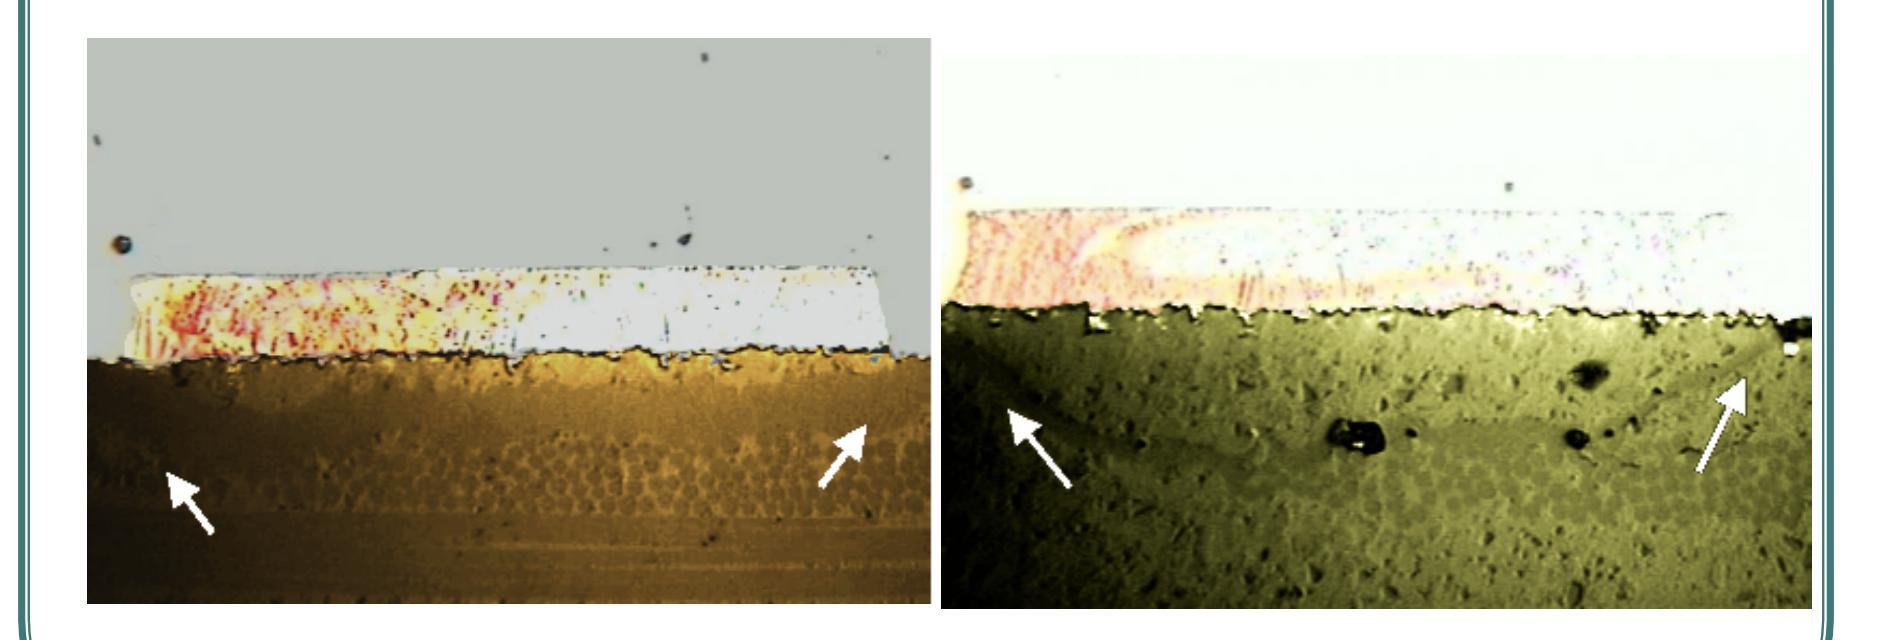
Cracking Under Pads (Cratering)

• Epoxy on the PWB board surface cracked away from the fibers within the board, allowing the copper pad to lift away from the board

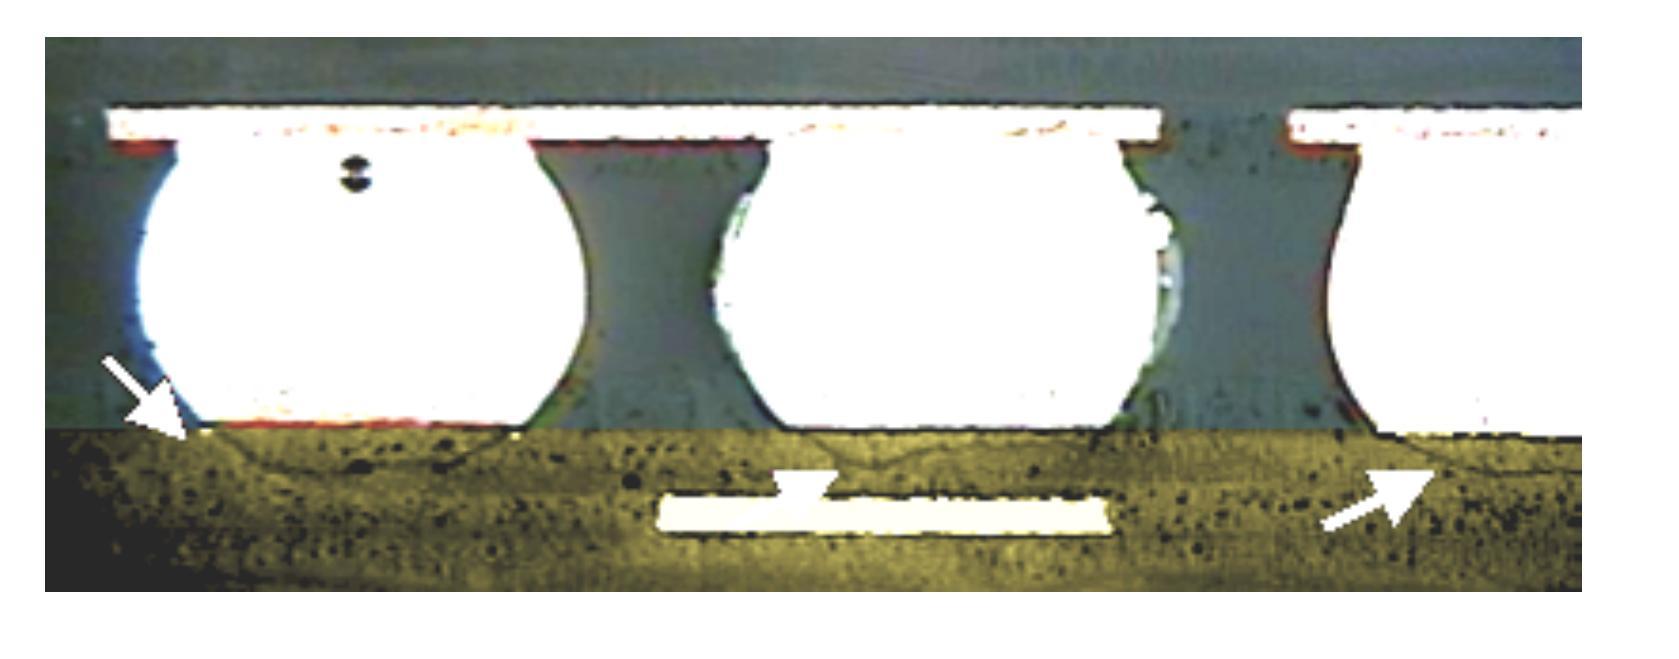
Cracking Under Pads (Cratering)

• Epoxy on the PWB board surface cracked away from the fibers within the board, allowing the copper pad to lift away from the board

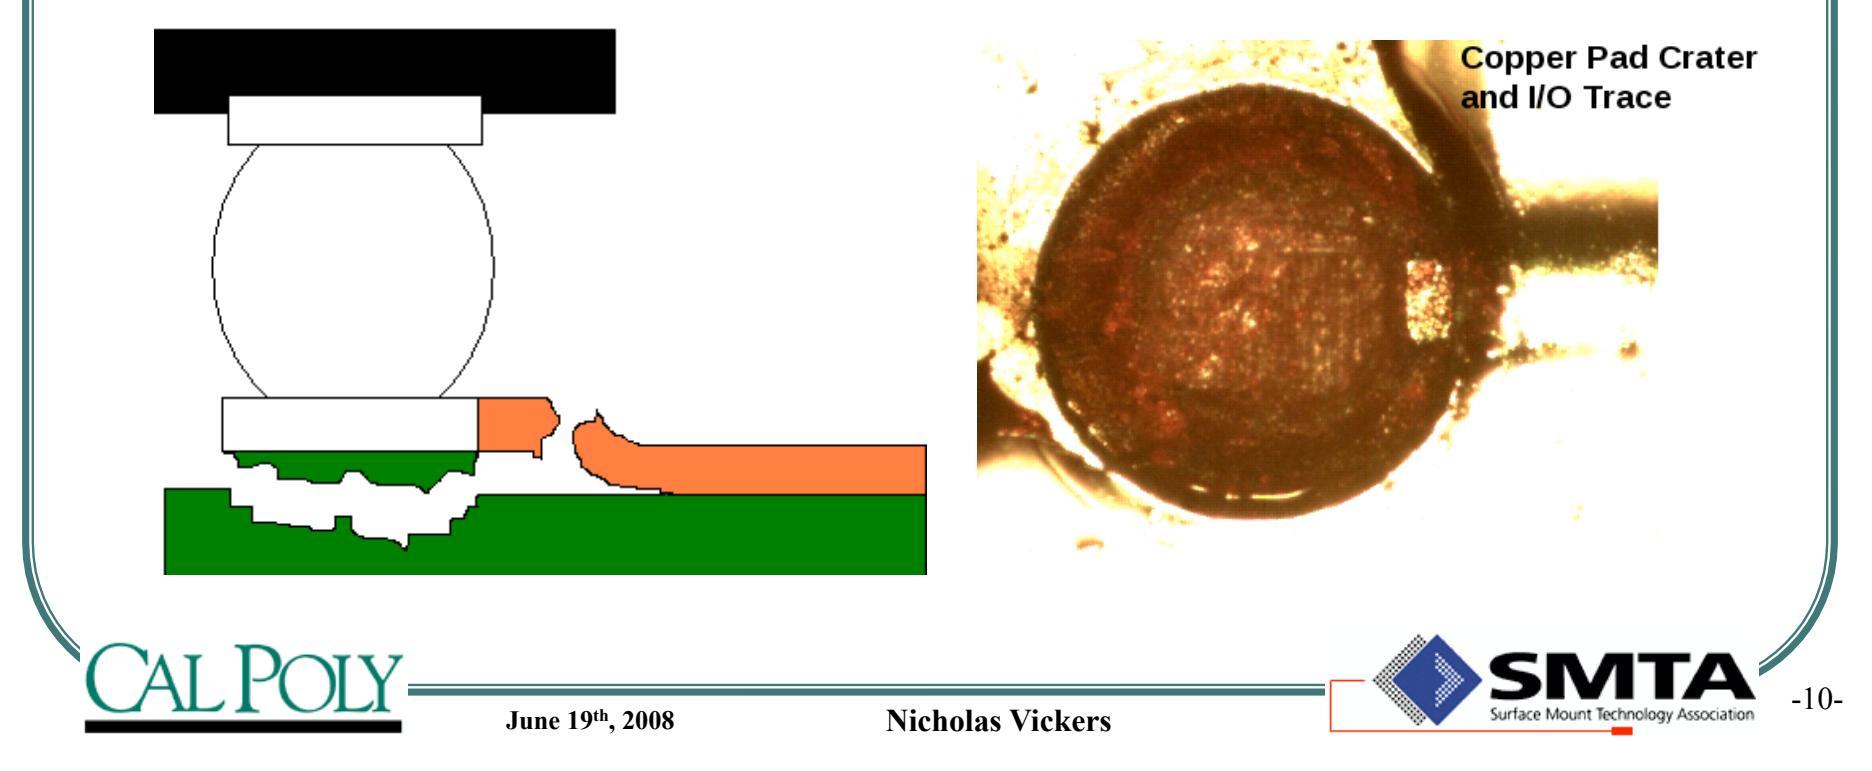
Input/Output Trace Failure

- I/O trace gets stretched when the copper pad lifts away from the PWB
- If the copper pad lifts far enough away, then ductile failure occurs in the copper trace

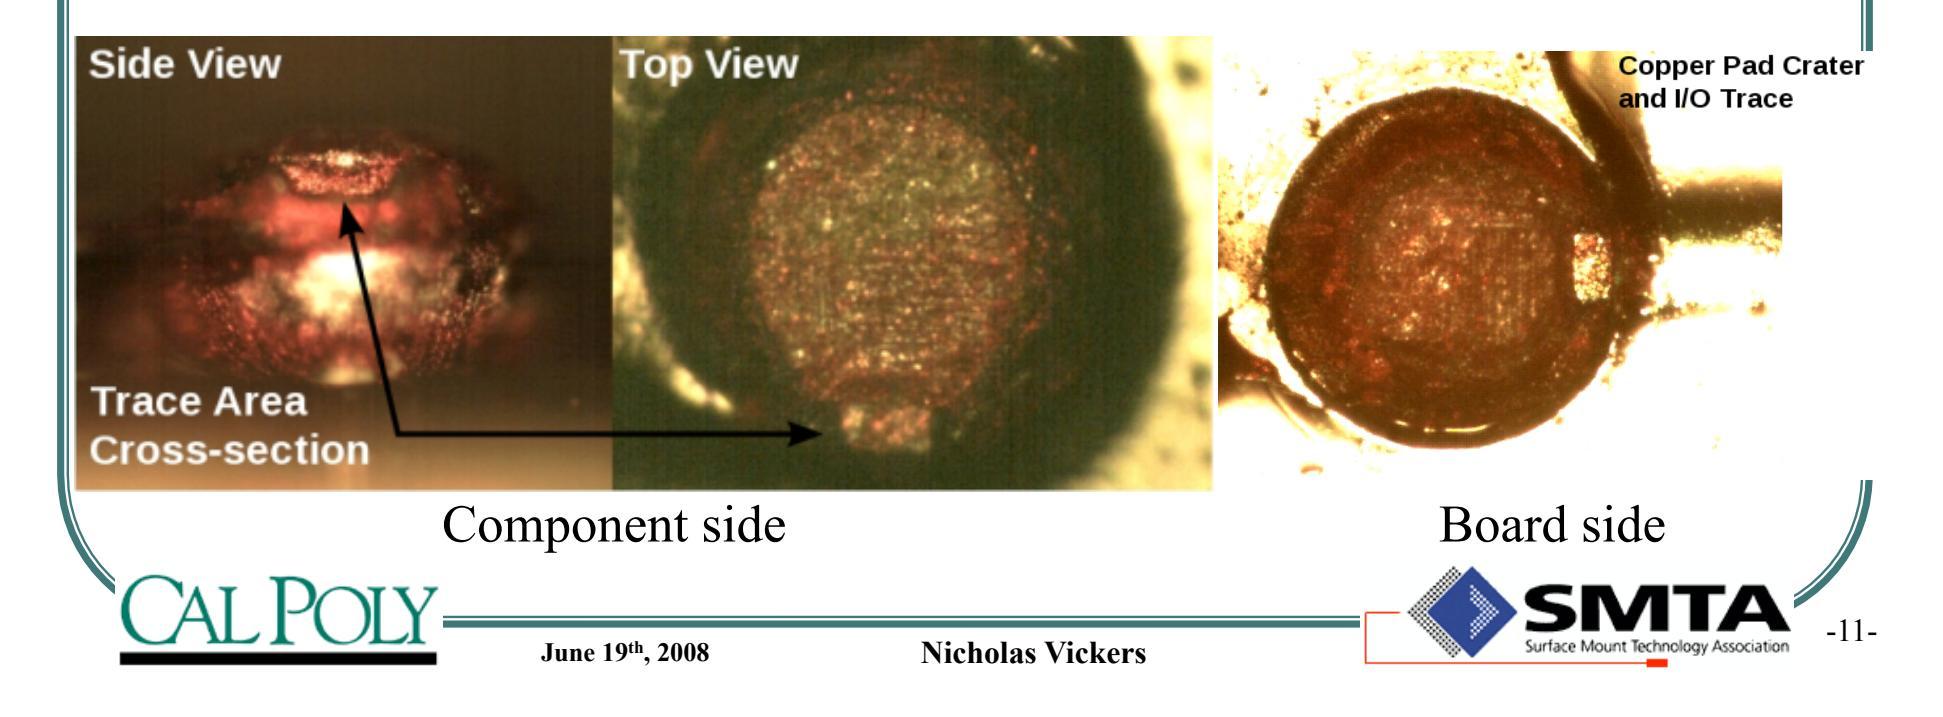
I/O Trace Failure

- Input/Output (I/O) traces that connect to the daisy-chain 'resistor' were often broken
- Many components had this broken trace and no other identifiable failure

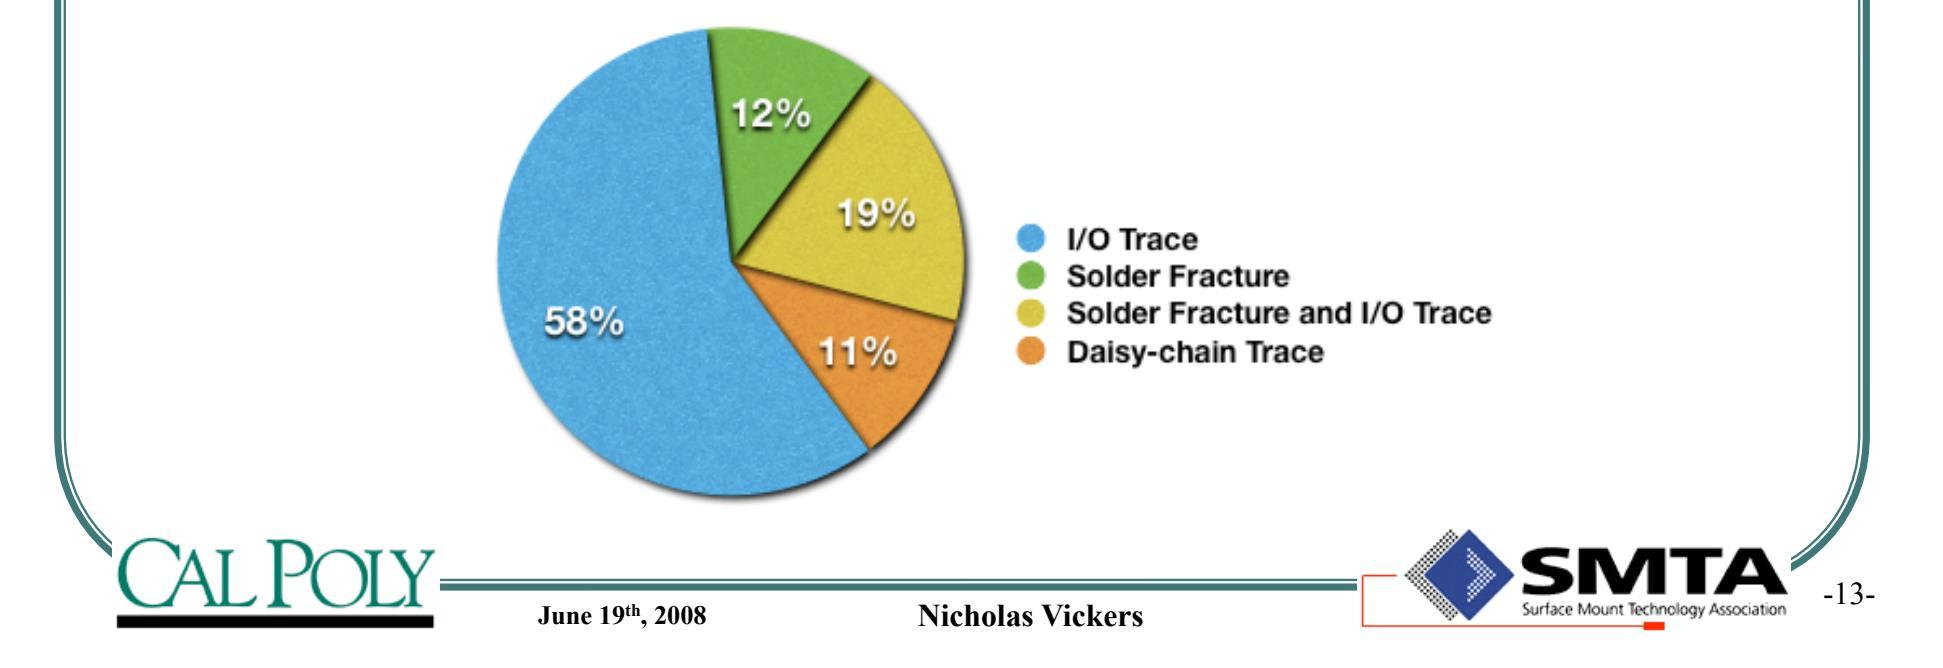
Failure Mode Comparison

- I/O Trace and Daisy-chain Trace failures are both caused by pad cratering
- Pad cratering was present on 88% of electrically failed components, and is directly responsible for 69% of electrical failures

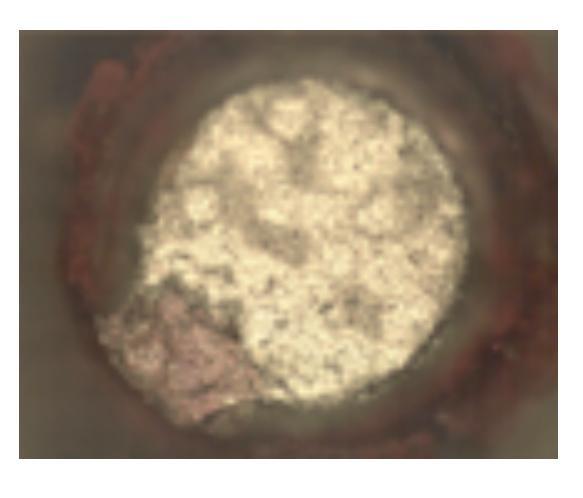
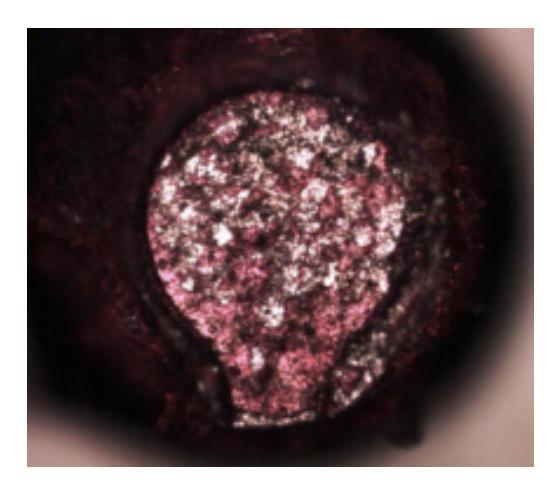
Dye Stained Solder Fractures

Dye stained solder fractures were found

- Partial solder fracture (left) was not completely fractured before the component was removed
- Complete solder fracture (right) was fully fractured before the component was removed
