Failure Analysis Techniques

Pad Cratering and Electrical Failure

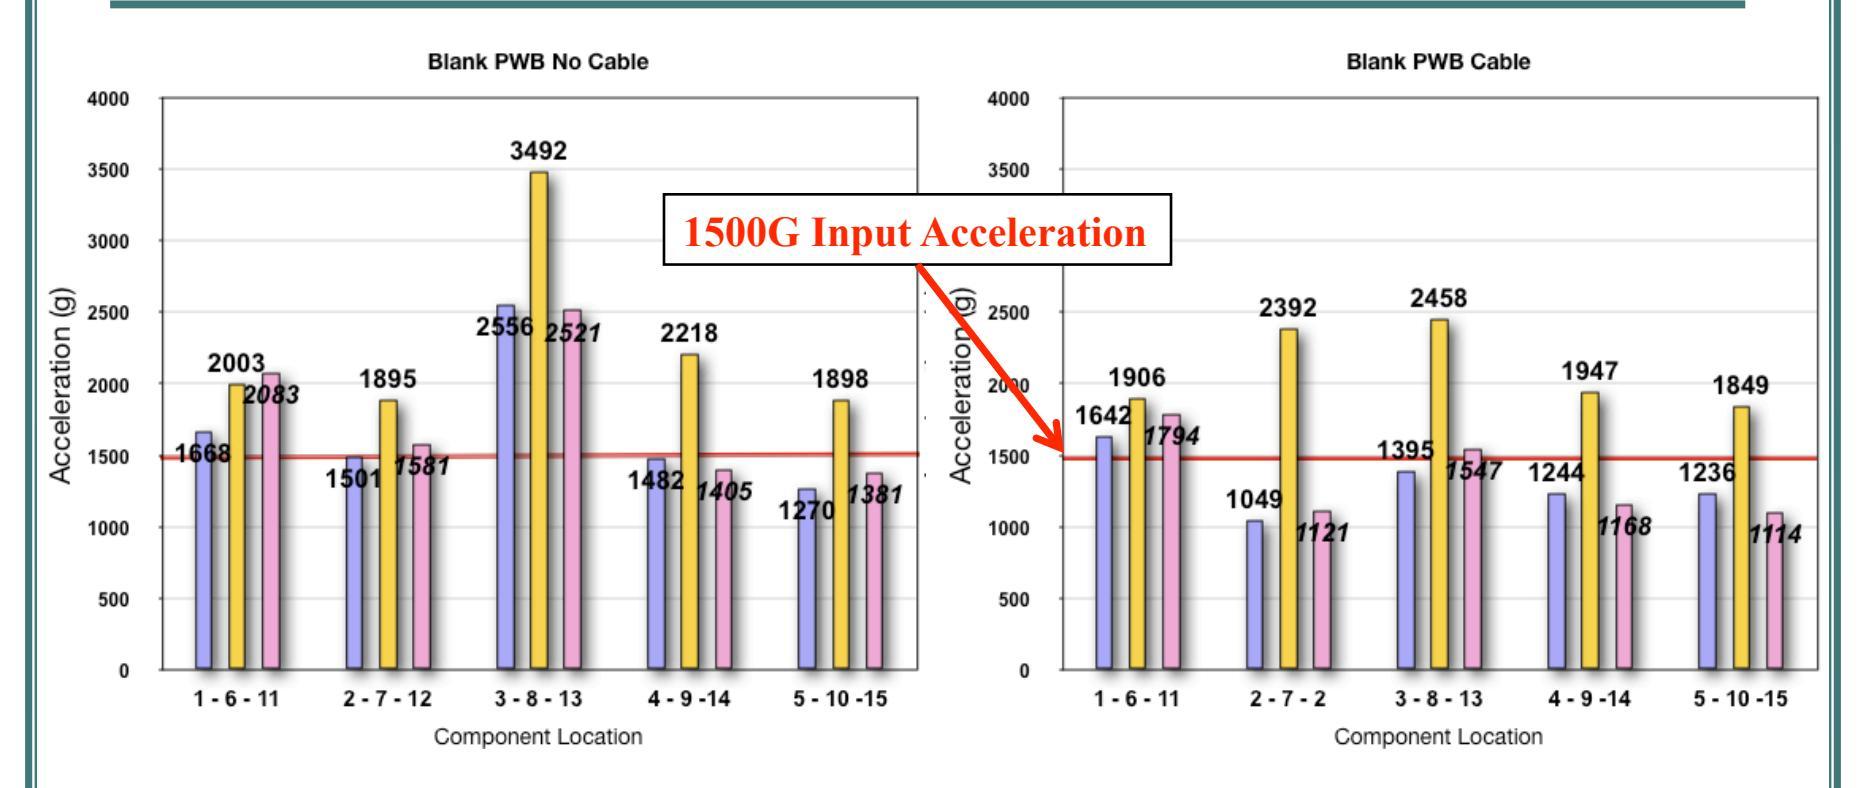
Blank PWB – No Cable vs Cable

- Symmetry of acceleration peaks has shifted (C7 vs C9)
- Maximums greatly reduced by cable (C3, C13, C8)

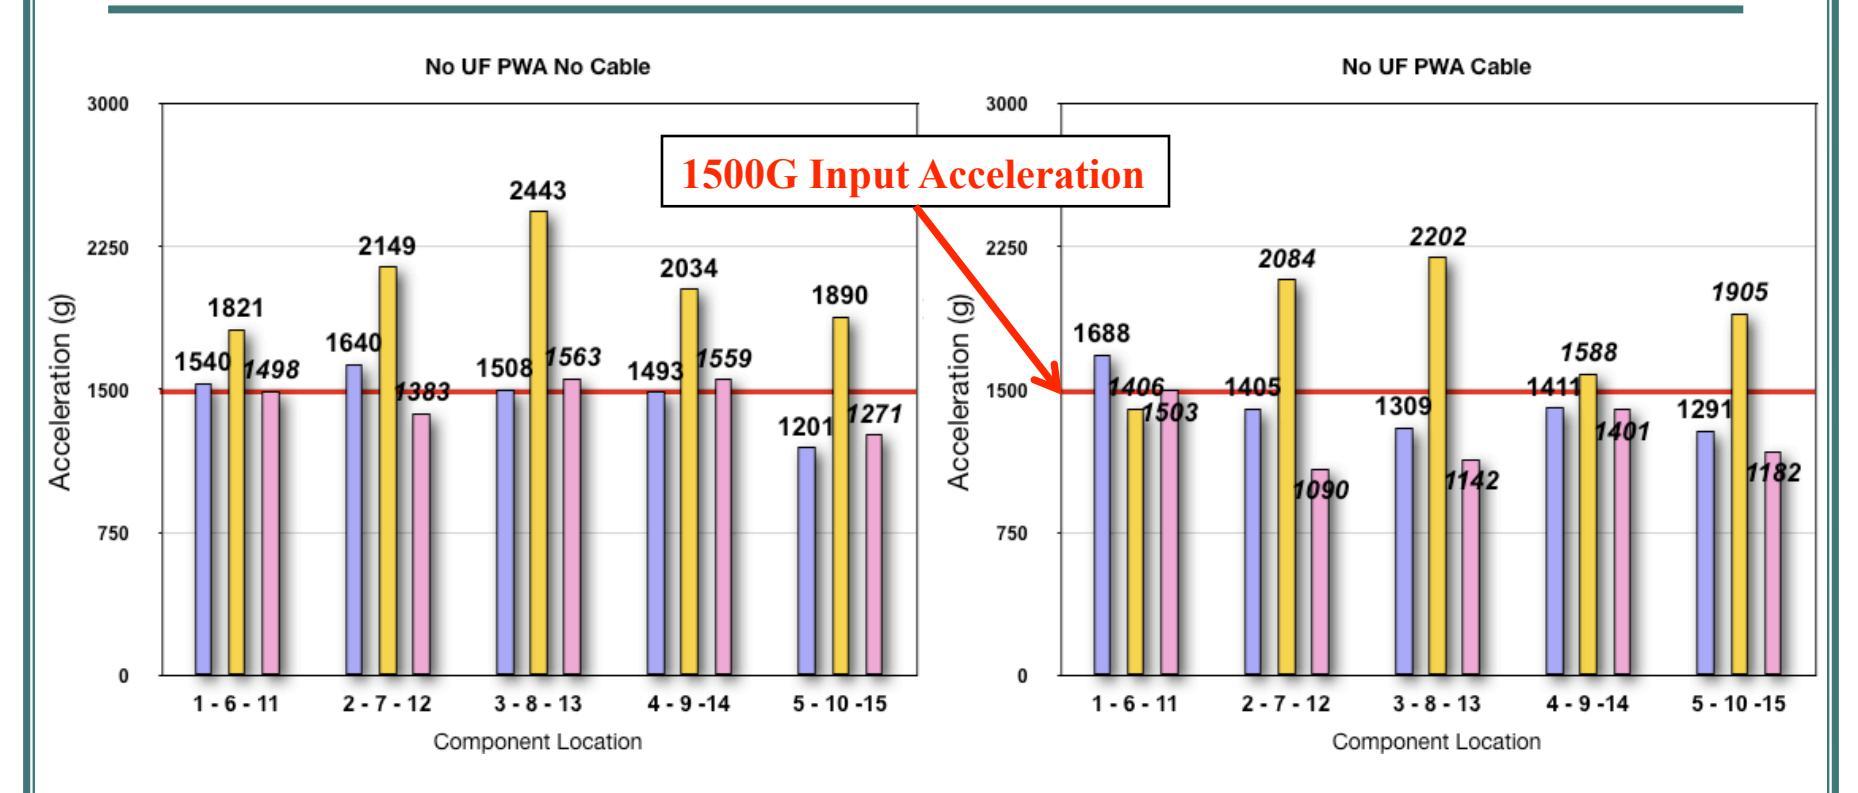
Populated PWB – No Edge Bond

• Dampening due to the cable seems less significant than with blank PWB (both graphs are more similar)

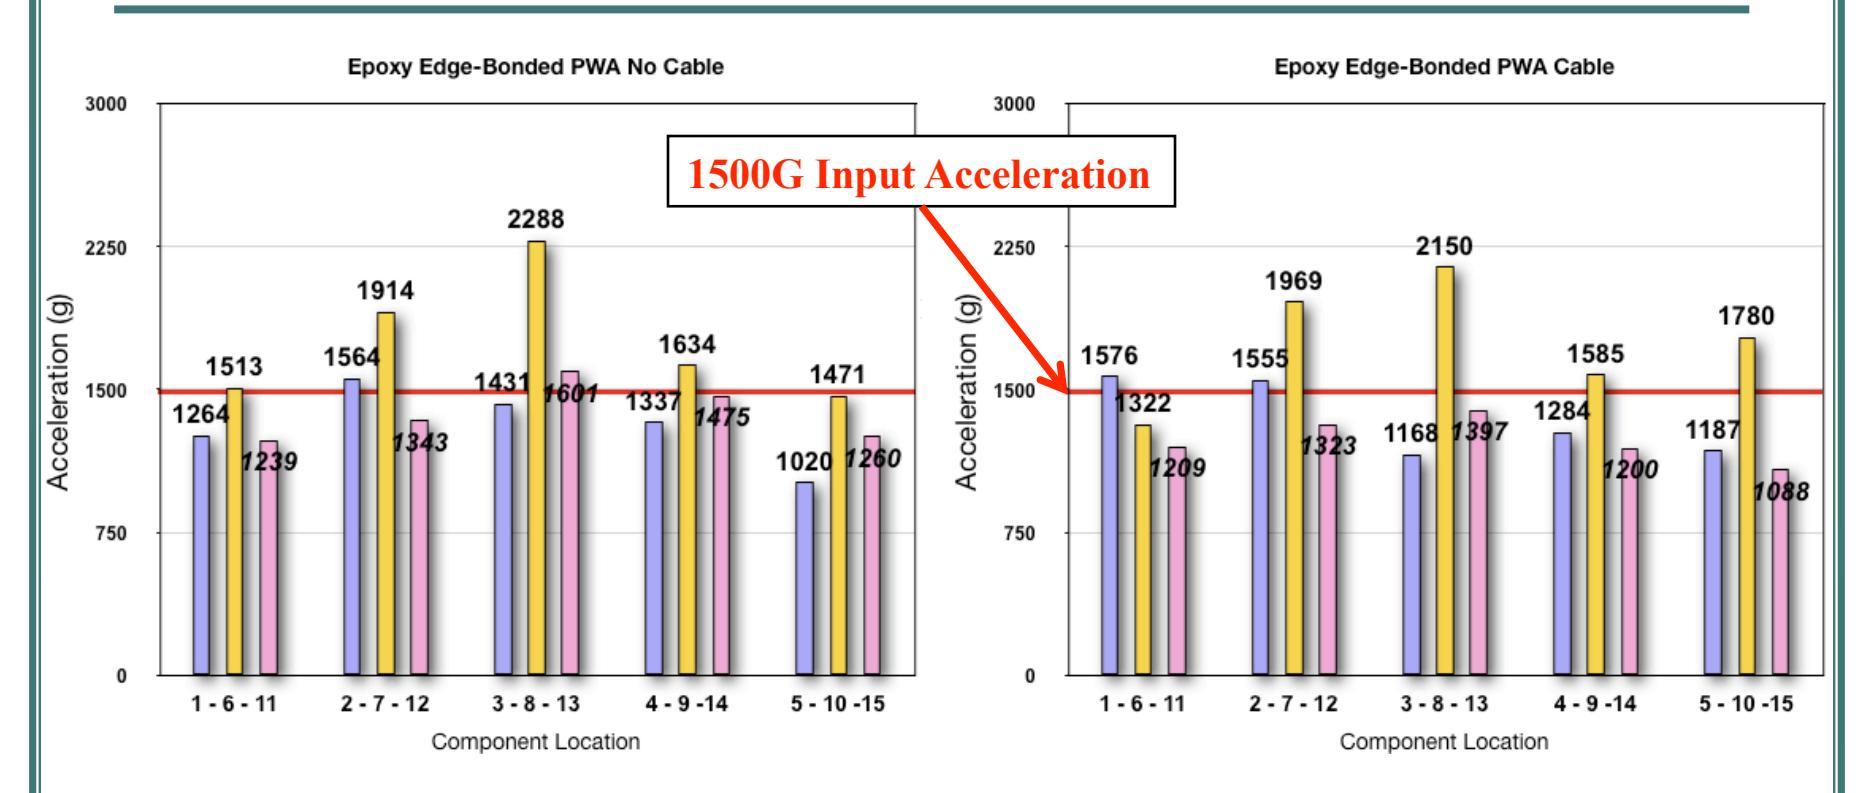
Epoxy Edge Bonded CSPs

- Stiffer board with edge bonding has less symmetry disturbance
- Overall accelerations are significantly reduced vs no edge-bond

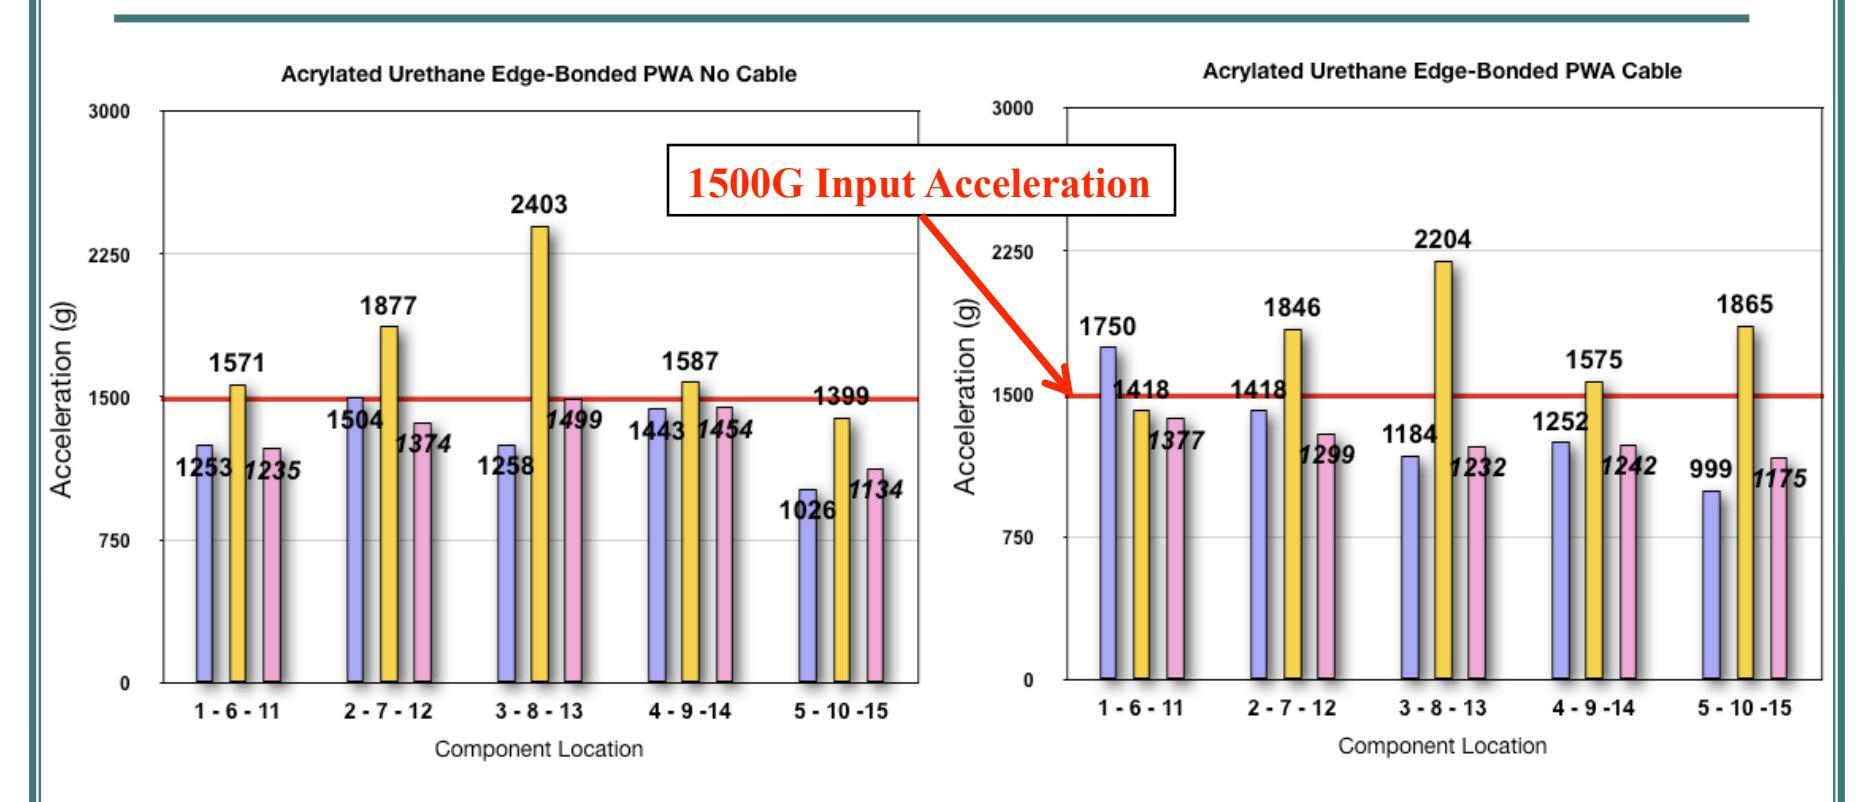
Acrylic Edge Bonded CSPs

- Stiffer board with edge bonding has less symmetry disturbance
- Overall accelerations are significantly reduced vs no edge-bond
