**58<sup>th</sup> ECTC, Lake Buena Vista, May 27–30, 2008**

## **Drop Test Reliability of Lead-free Chip Scale Packages**

Andrew Farris, Jianbiao Pan, Ph.D., Albert Liddicoat, Ph.D.  
California Polytechnic State University at San Luis Obispo

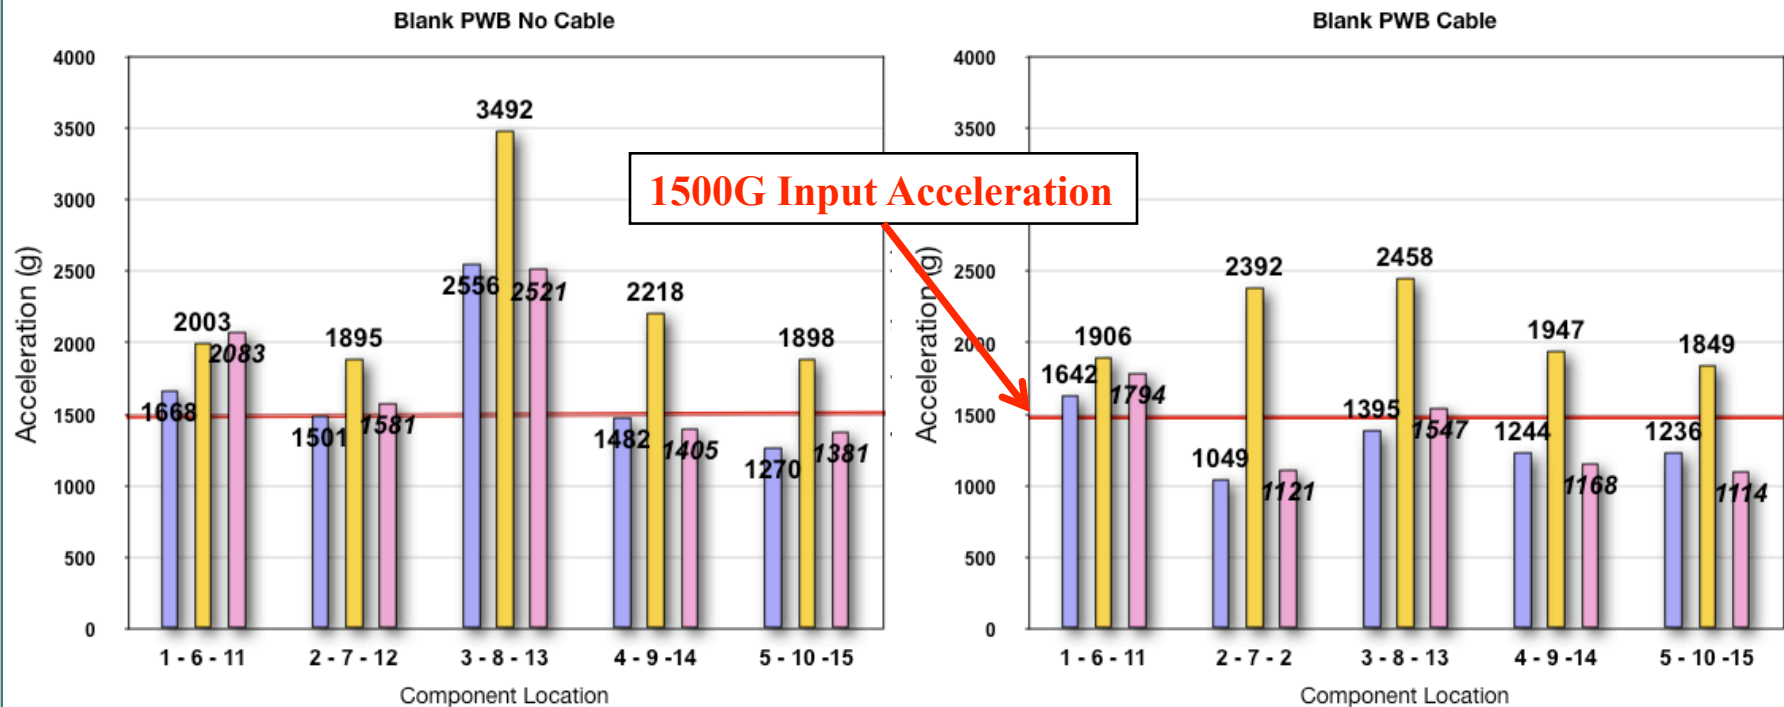
# Blank PWB – No Cable vs Cable

- Symmetry of acceleration peaks has shifted (C7 vs C9)
- Maximums greatly reduced by cable (C3, C13, C8)

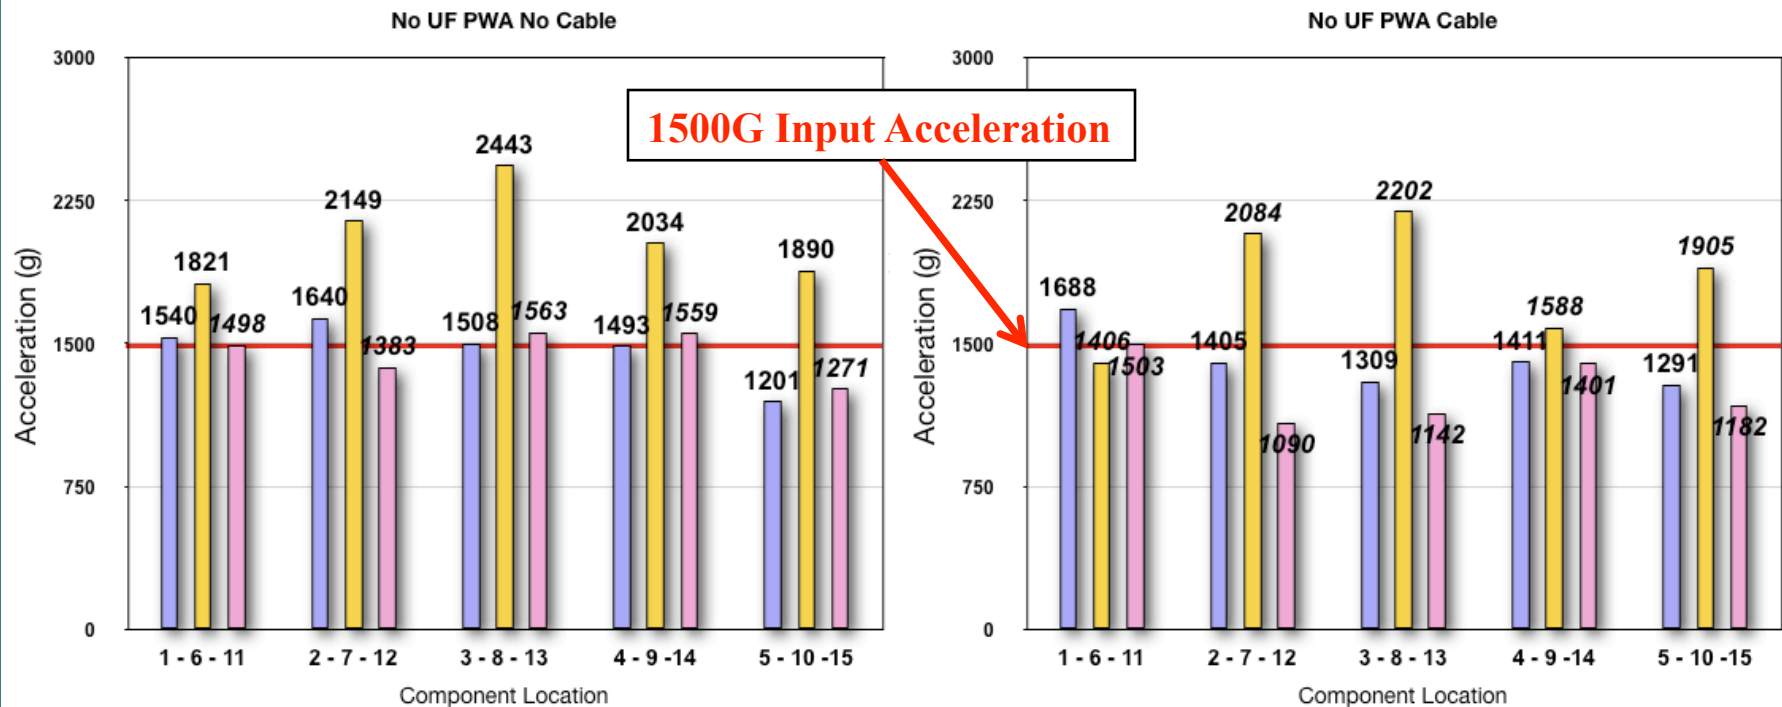
# Populated PWB – No Edge Bond

- Dampening due to the cable seems less significant than with blank PWB (both graphs are more similar)

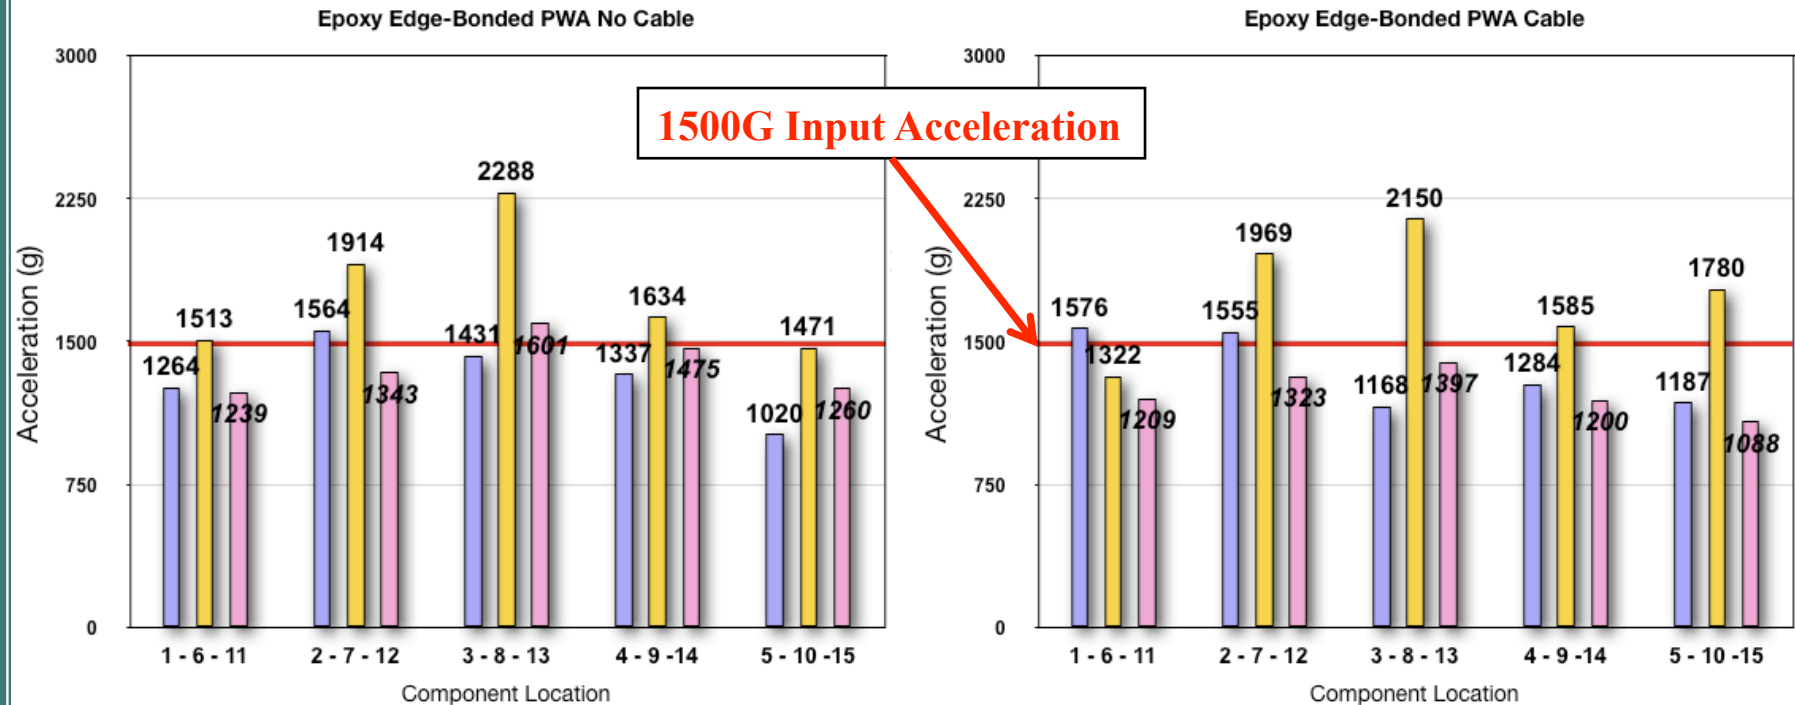
# Epoxy Edge Bonded CSPs

- Stiffer board with edge bonding has less symmetry disturbance
- Overall accelerations are significantly reduced vs no edge-bond

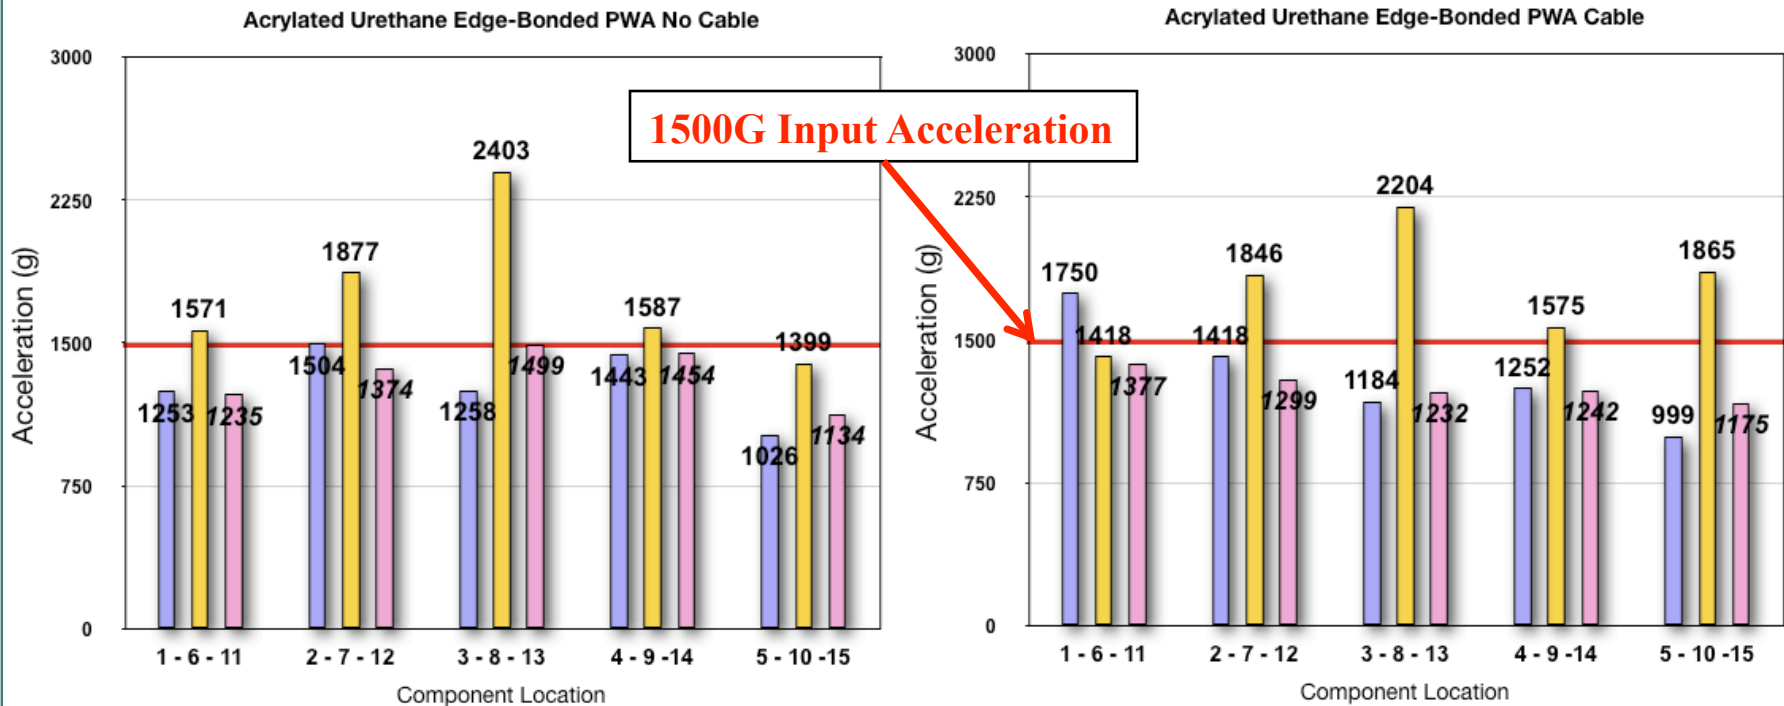
# Acrylic Edge Bonded CSPs

- Stiffer board with edge bonding has less symmetry disturbance
- Overall accelerations are significantly reduced vs no edge-bond

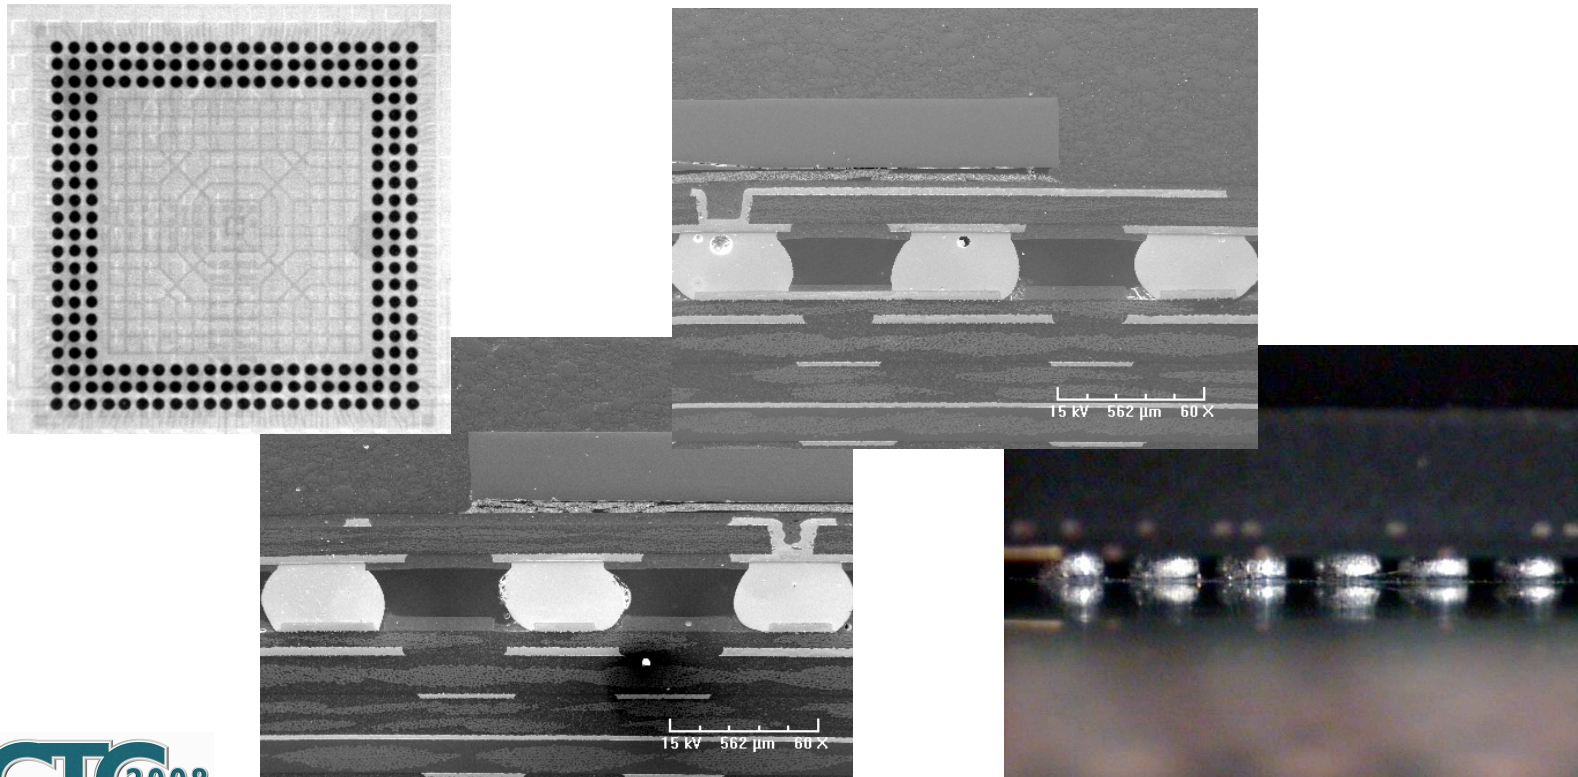
# Solder Joint Integrity after Assembly

- X-Ray and SEM images after assembly showed round, uniform, and well collapsed solder joints
